Subject: 2012 Montezuma Fire Fatality Factual Report

Montezuma Fire
June 8, 2012
Serious Accident Investigation Report

Location:
Bureau of Indian Affairs - Papago Agency
Tohono O'odham Tribe
Sells, Arizona

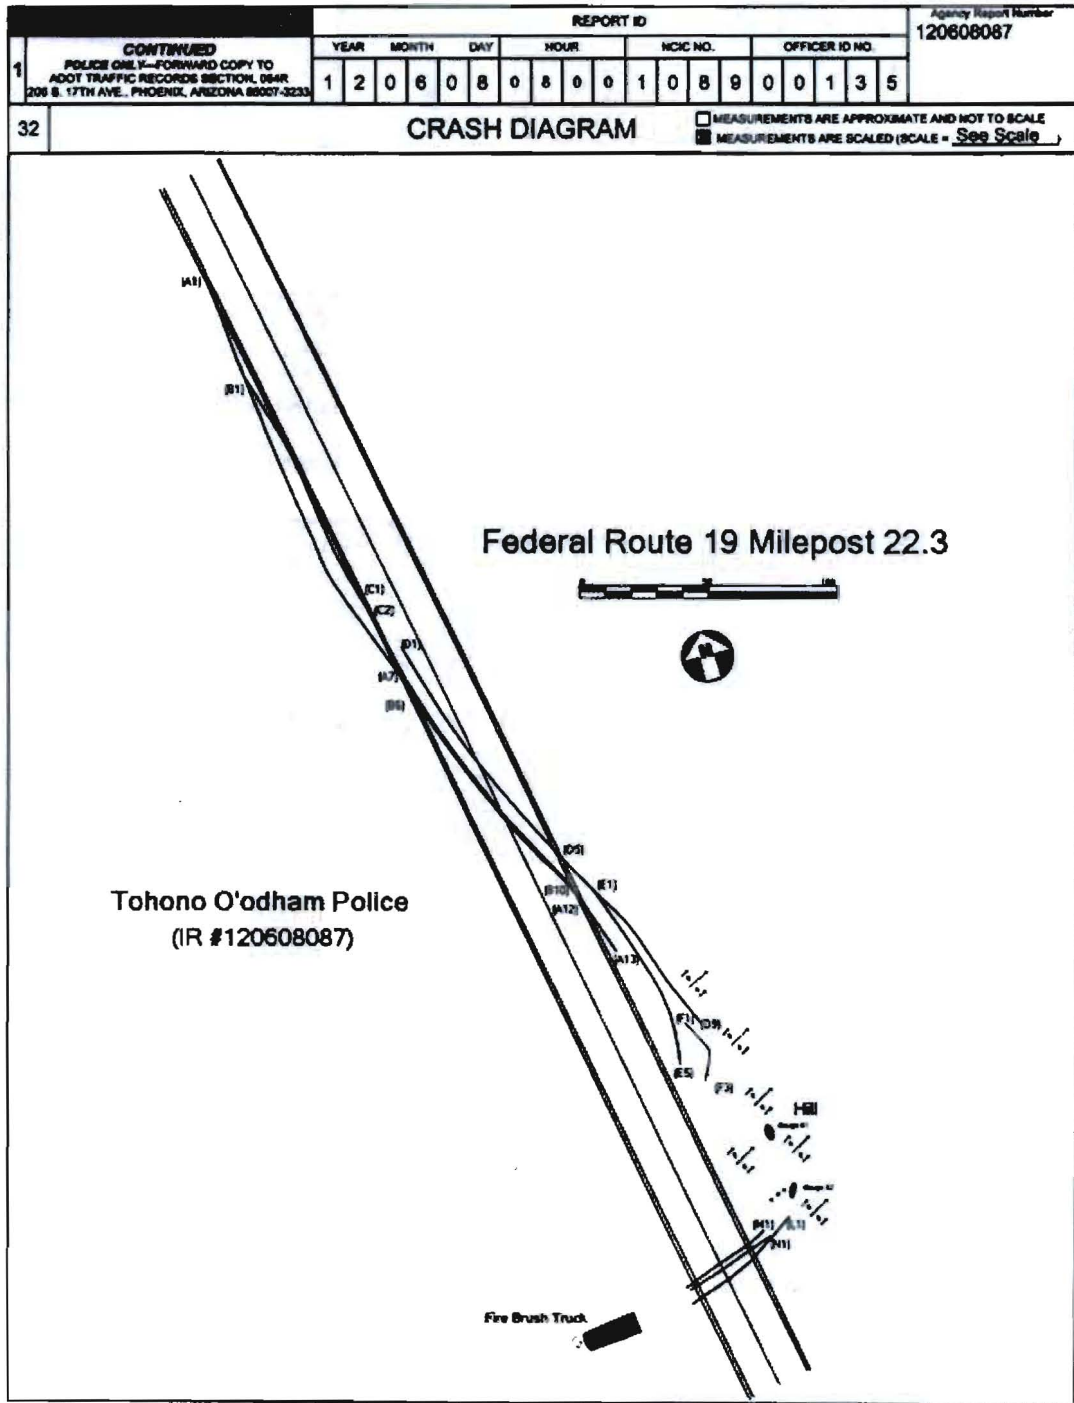
Crash diagram prepared by Tohono O'odham Police

As Crewmember 2 put the water bottle behind the back of his seat, he drifted off the right hand side of the road. He tried to steer the engine back onto the road, but overcorrected and went across both lanes of the road into the dirt on the other side. The engine flipped forward, landing with the weight on the hood and cab. The engine bounced, landed on its wheels and coasted across the highway (from east to west), coming to rest on the west side of the highway.

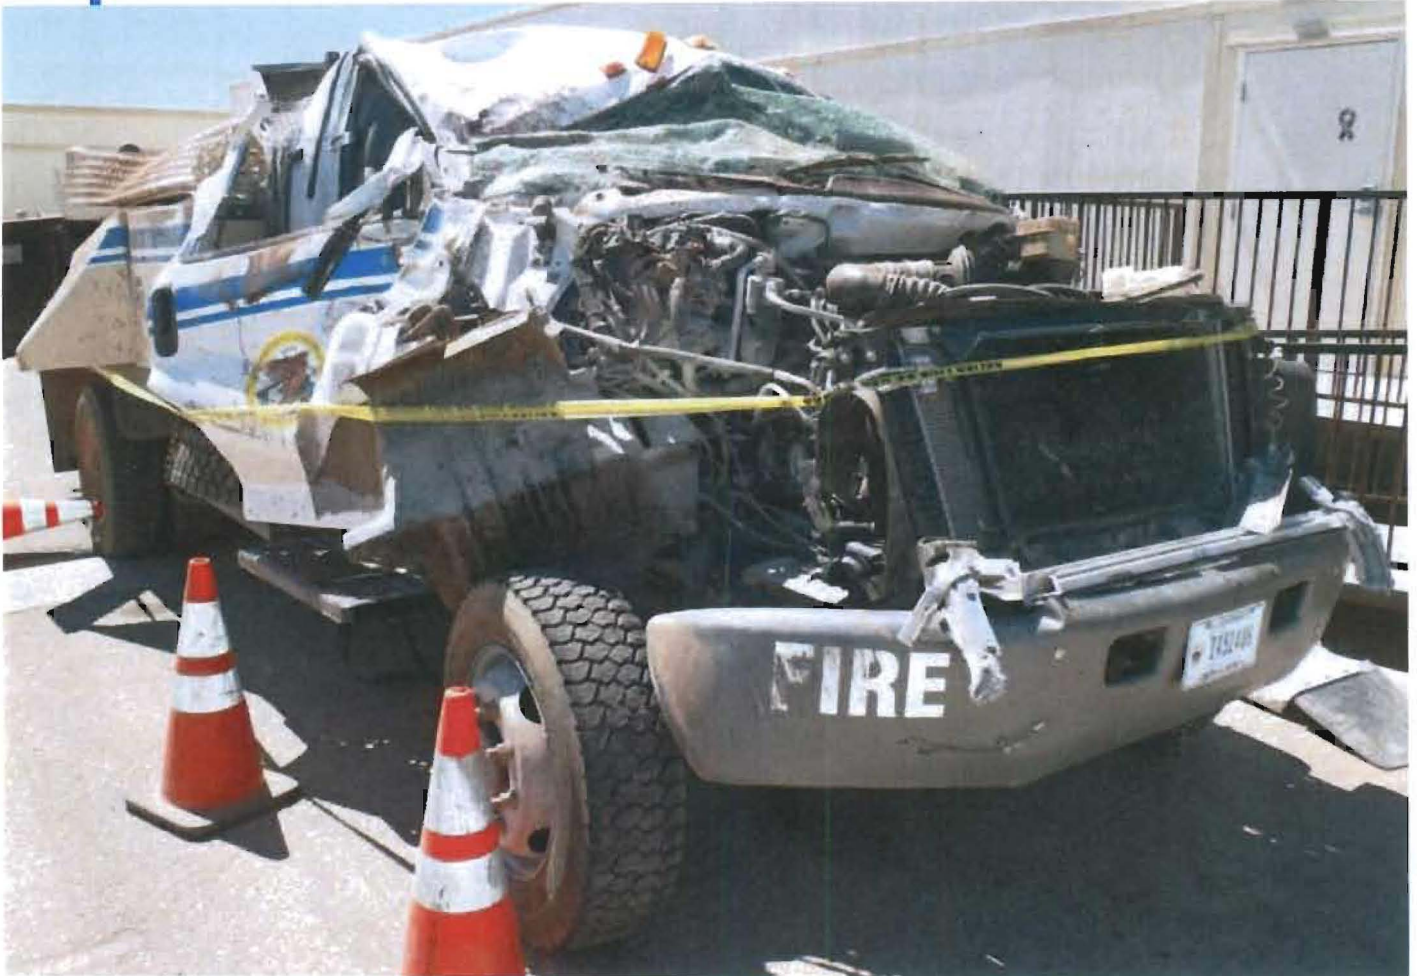
- b. The wear on the inside of the front passenger's side tire was consistent with the vehicle leaving the paved surface and rubbing on the pavement edge during the driver's attempt to return to the road surface.

Vehicle passenger side - The fatally injured employee was riding as the passenger.

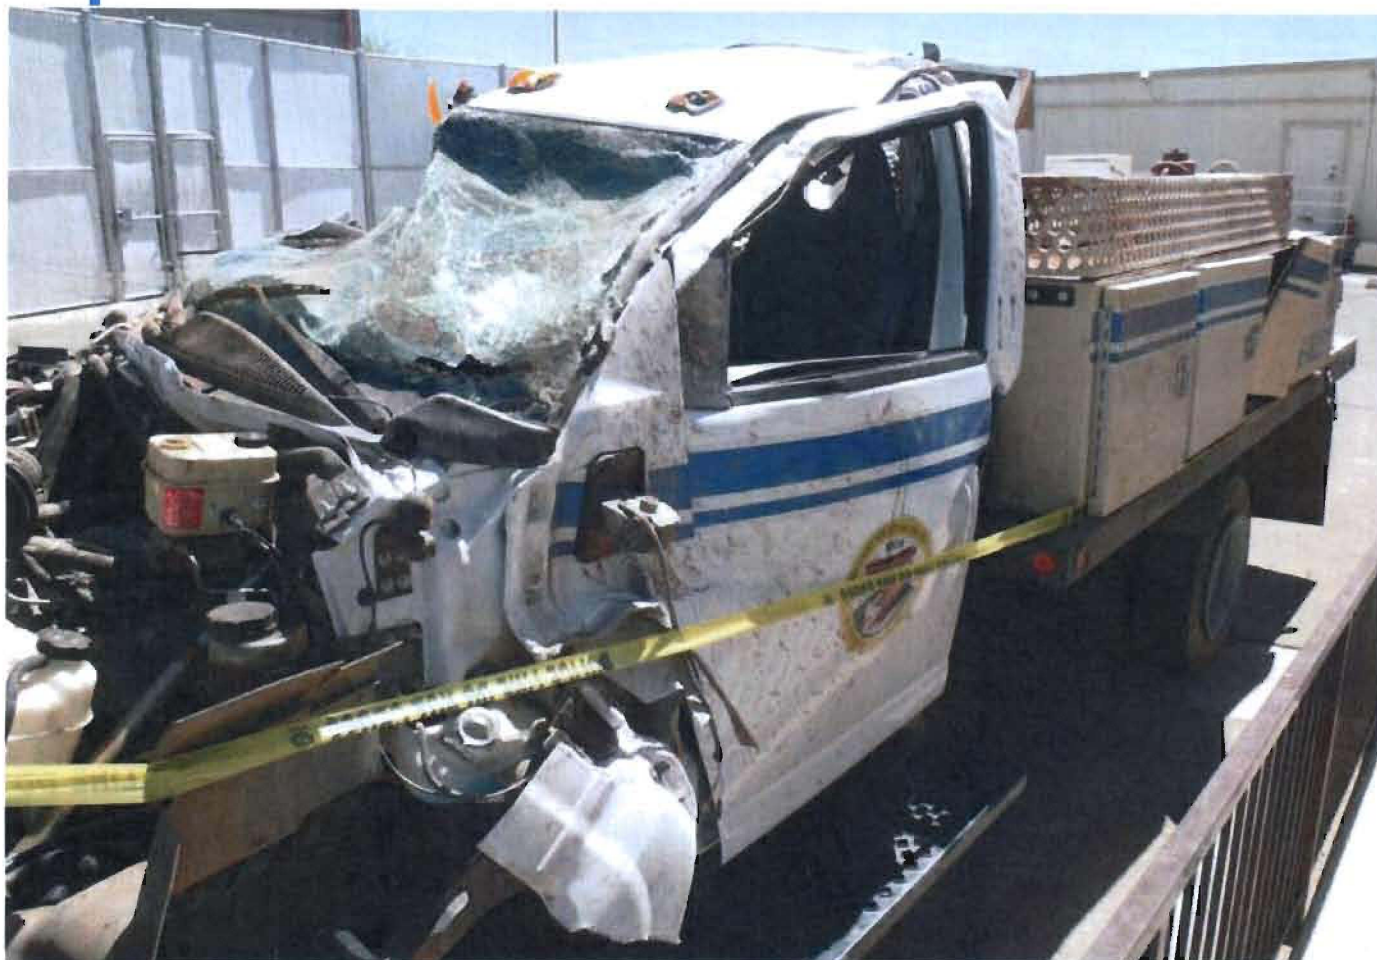
- c. Both the front and back outside dual, drivers' side tires, were off the rim due to the impact with the embankment which broke the seals of the tires. Tohono O'odham Nation Vehicle Accident Investigator, Marty Fuentes stated this action was normal in this type of accident.

Vehicle driver side - Crewmember 1 (middle passenger) and Crewmember 2 (driver) successfully exited the vehicle through the driver side window following the accident.
