Weber Dam Response

Key Messages July 19, 2023

Emergency Action Plan Response Level One

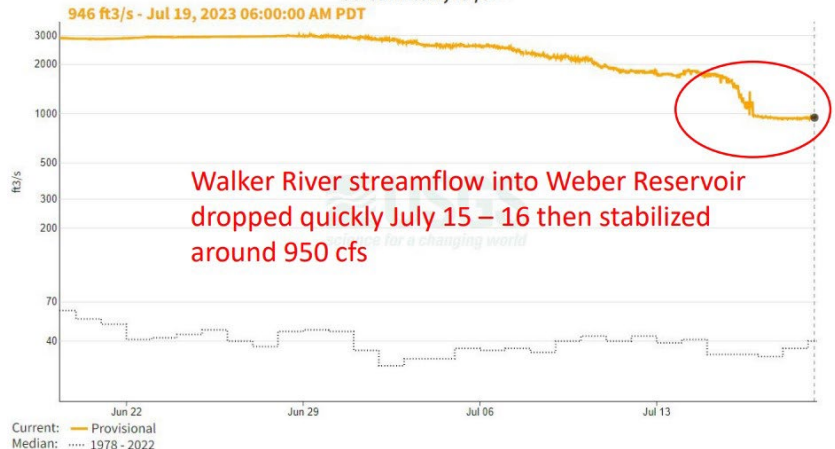
Walker RV Abv Weber Res NR Schurz, NV - 10301600

The average stream flow above Weber Reservoir for the month of July (records date back to 1901) is approximately 250 cubic feet per second (cfs). The streamflow into the reservoir is currently 950 cfs. This is almost four times the average streamflow into the reservoir that would occur at this time in a normal year.

June 19, 2023 - July 19, 2023

Streamflow, ft³/s ⓘ

- With this current rate, the gates of the service spillway need to remain open.
- Assuming the service spillway continues to function normally, BIA anticipates closing the spillway gates and filling the reservoir when the streamflow into the reservoir drops to approximately 700 cfs.
- Best estimate projections for when streamflow rates will return to normal are based on National Weather Service 30-day forecasts. At present flow rates, BIA does not anticipate closing the service spillway gates before sometime in early September.
- An inspection of the spillway chute will occur after the service spillway gates are fully close.
- Once streamflow into the reservoir drops below 575 cfs, the dam operators can resume their normalized irrigation operations and control the reservoir water level using the outlet works (tunnel) and fishway with the service spillway gates closed.
